**US Army Corps
of Engineers®**
Engineer Research and
Development Center

Evaluation of 4-Foot Muscle Wall Flood Fighting Barrier

Efrain Ramos-Santiago, Curtis Blades, James D. Gutshall

May 2020

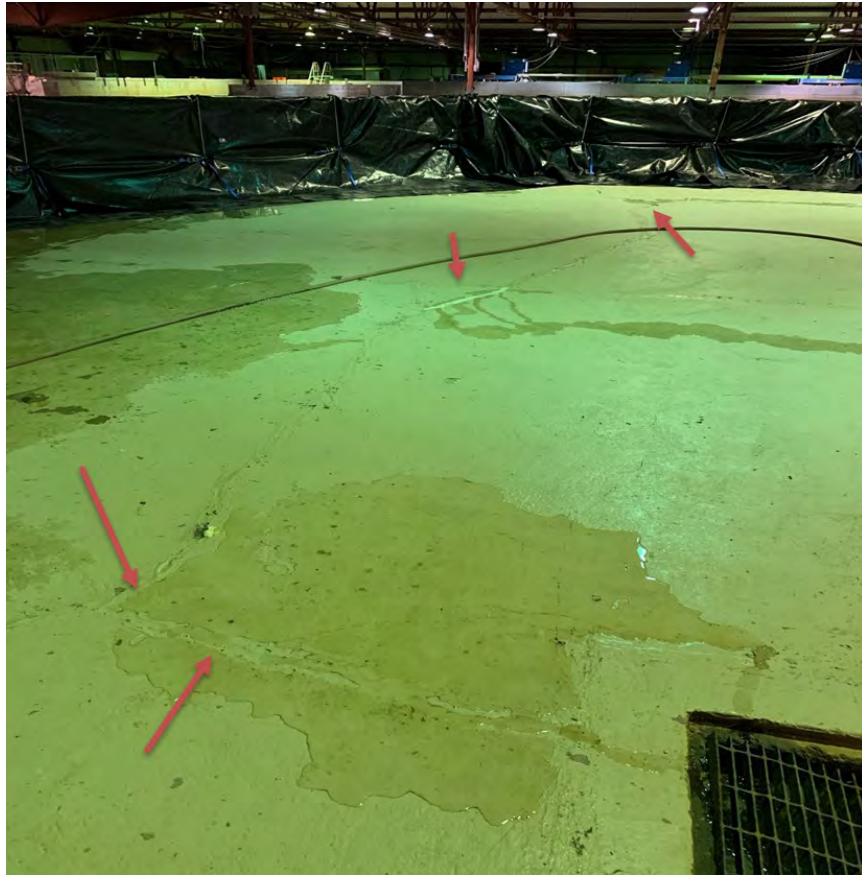
Figure 18. Upward flow through cracks within the test area (1 ft. basin water depth).

Cracks in the basin floor were last cleaned and sealed in December 2018 and again in February 2019. Prior to this test, no other attempt was made in this regard due to time constraints. Seepage through some of the floor cracks was observed when test basin had a water depth of 2 ft. or greater (Figure 18). These were measured with a calibrated cylinder as accurately as possible, then adjusted to account for smaller seepage holes that were observed but too small to measure. The adjusted floor crack seepage rates are shown in Table 2. The measured rates for a similar hydrologic test performed on March 2018 are also presented for comparison. Total seepage through the floor at a basin depth of 3.94 ft. was estimated at 0.006 gpm/ft. In this report, floor seepage at a basin depth of 1 ft. will be neglected, floor seepage at a depth of 2 ft. will be estimated at 0.0002 gpm/ft.

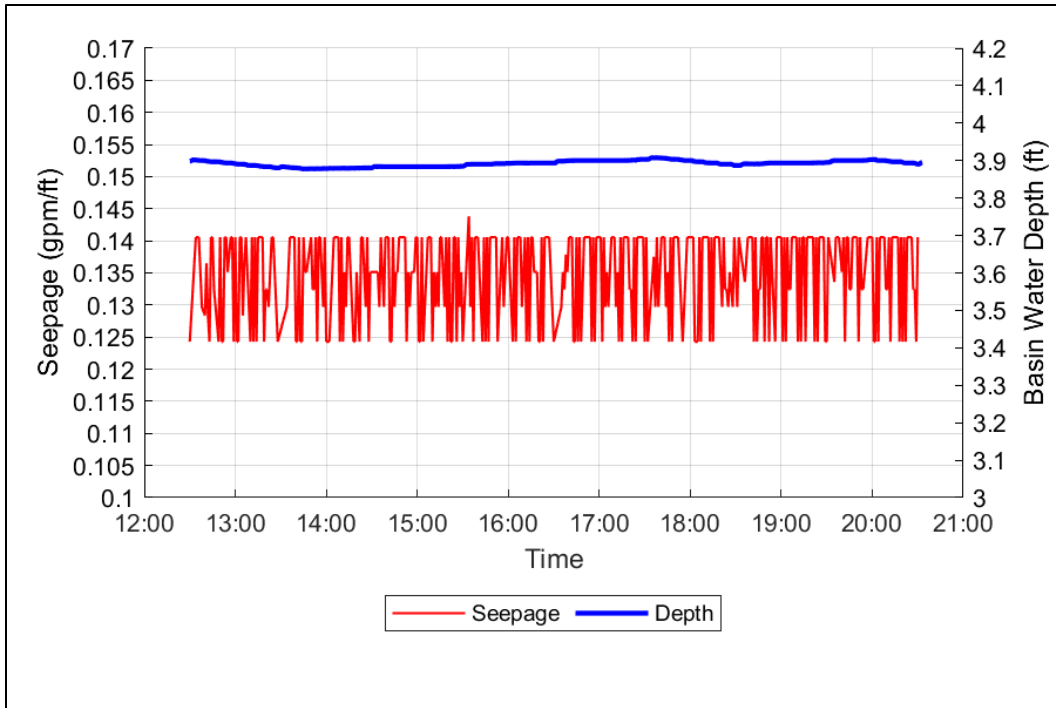
Figure 22. Seepage rates during final eight hours of the 100 percent depth hydrostatic test.

Seepage increased as the water level in the basin was raised from 2 ft. to 3.89 ft., as expected. The average seepage of the test was 0.135 gpm/ft., after subtracting the 0.006 gpm/ft. floor crack seepage (see Table 2). A segment of the seepage time series for this test is shown in Figure 22. After completion of this test, the drain valve was opened at 20:45 to lower the basin water depth. At 22:30 the drain valve was closed, the water depth was 3.46 ft., and the basin was left to drain overnight through floor crack seepage as shown in Figure 23. The average seepage rate dropped during this time (22:30 28 Feb to 08:00 29 Feb) to 0.117 gpm/ft., after removing the effects of floor crack outflow and outliers introduced by the seepage pit pumps.

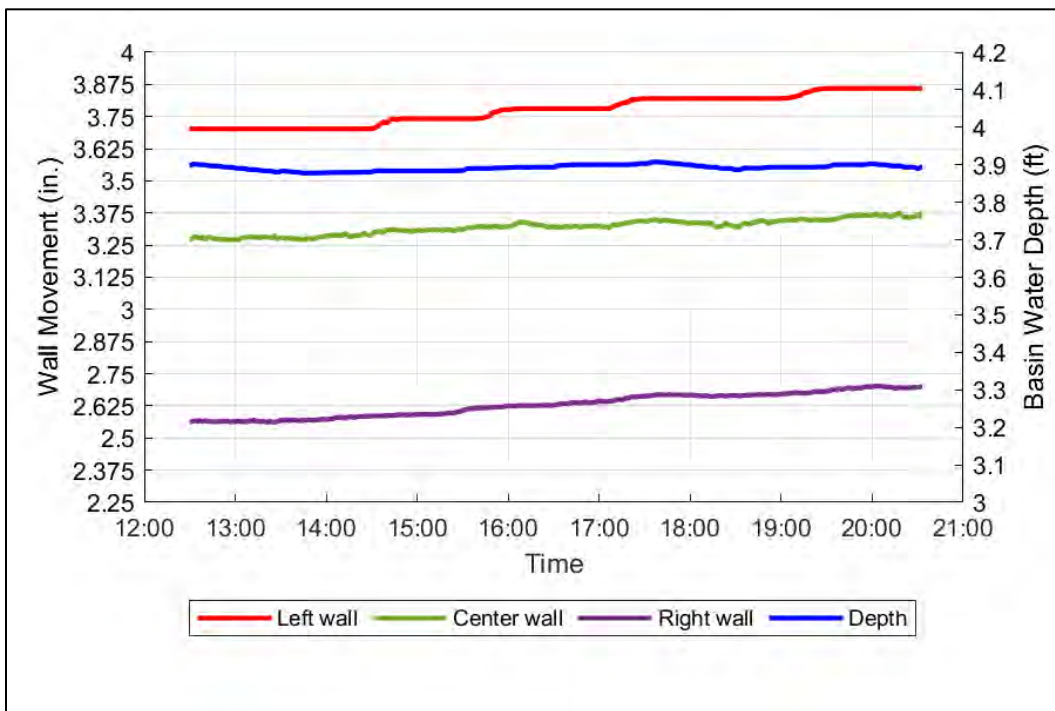
Figure 24. Movement of barrier during final eight hours of 100 percent depth hydrostatic test.

The flood barrier movement time series for the final 8 hours of this hydrostatic test is illustrated in Figure 24. It was found that all three sides of the flood barrier moved inward or into the basin's dry-zone. The left wall moved 3.86 in.; the center wall moved 3.37 in., and the right wall moved 2.70 in. However, this data does not provide the base to conclude that the flood barrier either slipped or tipped at any of these locations. The laser system is not equipped to measure additional parameters other than distance.

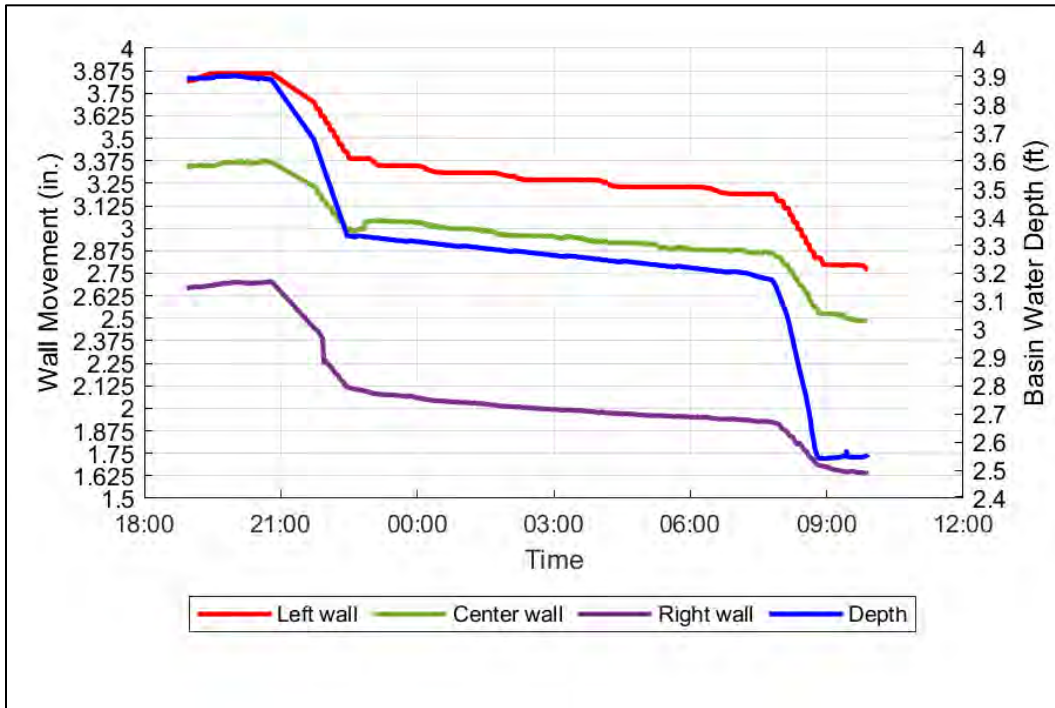
Figure 25. Movement of barrier between 22:30 28 Feb and 08:00 29 Feb.

As mentioned before, after concluding the 100% depth hydrostatic test, the basin was left to drain overnight. In the following morning, 08:00 29 Feb, the drain valve was fully opened again to take the water depth to 66.7% of the structure design height required for the wave test. From the laser data shown in Figure 25, it was observed that all three walls of the flood barrier had a rebound of nearly an inch after draining. These measurements are summarized in Table 3 along with the results obtained for the 100% depth hydrostatic test. The negative sign of the total movement results indicates

that the motion was in fact towards the basin’s wet-zone. This is an indication of the Muscle Wall ability to bend without significantly slipping its base, a combined effect of the hollow plastic structure with the orange base liner.

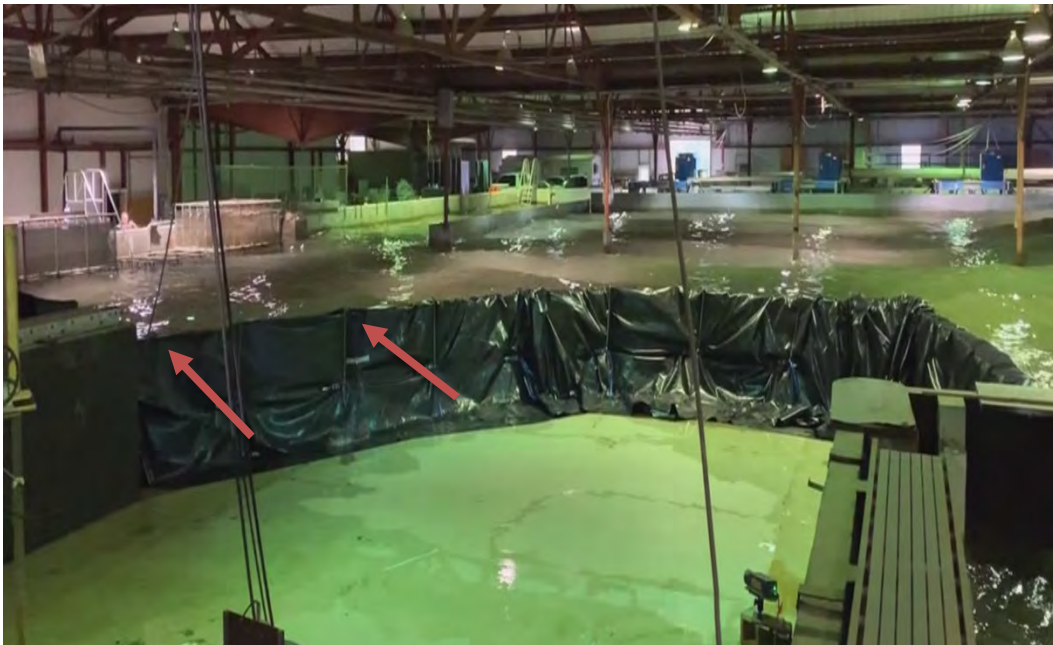
Figure 30. Overtopping during the test with large waves at low water.

The large waves were generated for a single 10-min run starting at 08:58. Waves overtopped the left wall near its center and near the wingwall; no overtopping of the right and center walls was observed (Figure 30). Average seepage rate (including overtopping) were 0.100 gpm/ft., adjusted for floor seepage (Figure 31). There was no noticeable movement of the flood barrier walls (Figure 32).

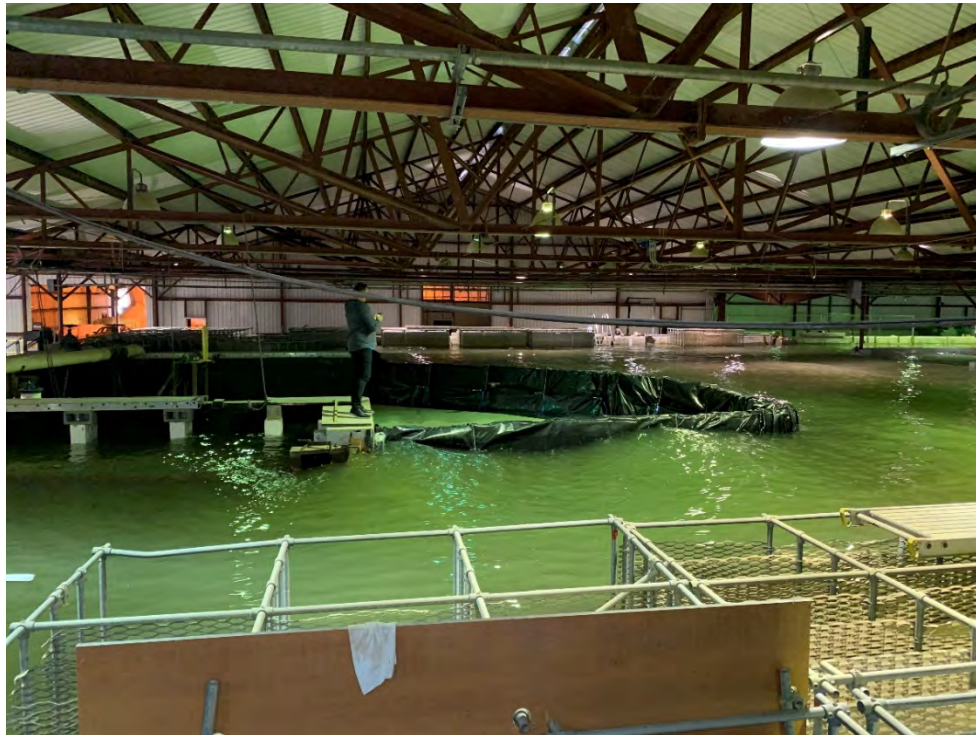
Figure 35. Flood barrier during the test with medium wave heights at high water.

Overtopping was observed near the center of the left wall. The peak measured overtopping rates (one-minute average) was 0.16 gpm/ft. and the average overtopping rates for the 10-min runs was 0.12 gpm/ft.

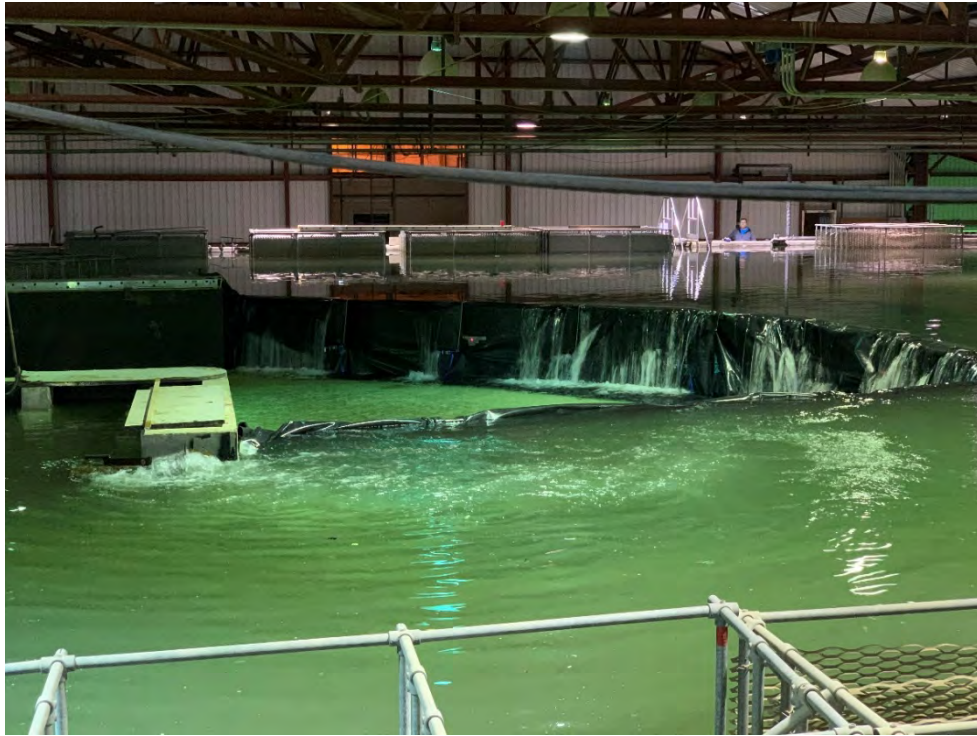
Figure 40. Overtopping of 4-Foot Muscle Wall during overtopping test.

The overtopping test was conducted by raising the water level in the basin until water was flowing over the barrier at an average depth of 1 in. Because the liner cover was not tighten up to the barrier's top side, the crest elevation of the flood barrier varied which caused some areas of overtopping to be greater than others, while some areas had no overtopping. The test engineer estimated when the overtopping reached an average depth of 1 in., then stopped filling the basin and allowed the water to overtop the barrier for one hour before opening the drain and lowering the water level in the basin (Figure 40).

Throughout the test, the 4-Foot Muscle Wall retained structural integrity and suffered no noticeable damage.

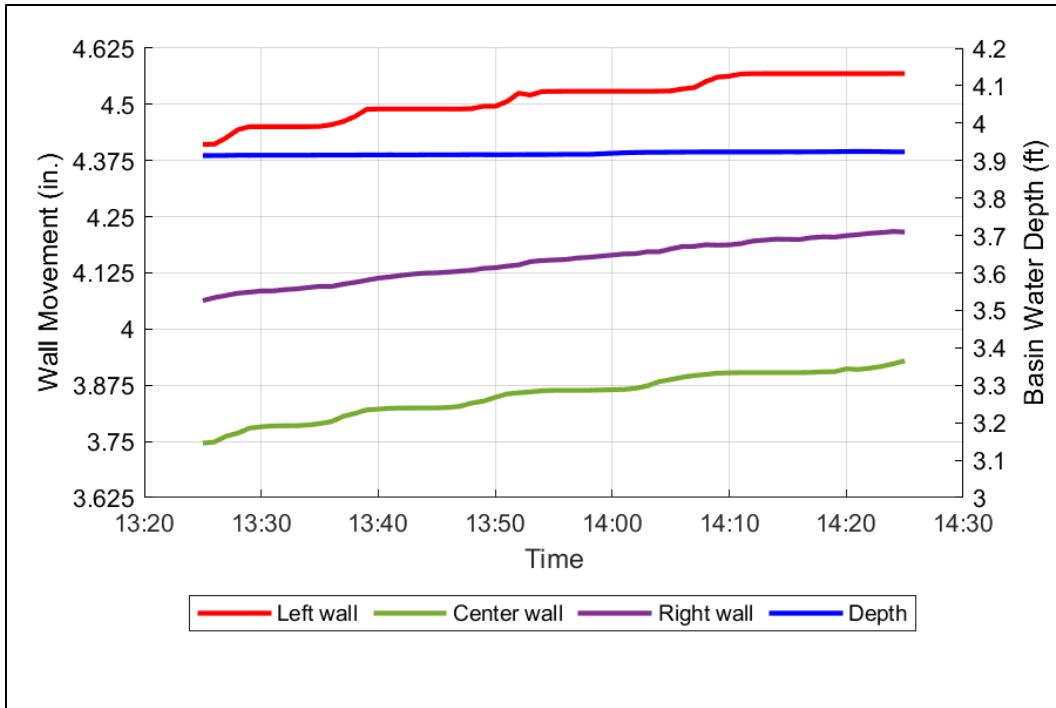
Figure 50. Movement of barrier during post hydrostatic test.

The pumps were turned on again at 11:30 on 04 March 2020 and a water depth of 3.94 ft. was reached at 13:25. The test concluded at 14:25. Average seepage rate was 0.085 gpm/ft. (adjusted for floor crack outflow; see Table 2) for the time series shown in (Figure 49). The wall movement is summarized in Table 8, and the time series per wall are illustrated in Figure 50 for the test duration. As expected, the barrier walls moved significantly compared to the position recorded by the end of the riverine

current test, but did not surpassed the 6 in. maximum permanent deflection required by the Standards.
