**US Army Corps
of Engineers®**
Engineer Research and
Development Center

Evaluation of 4-Foot Muscle Wall Flood Fighting Barrier

Efrain Ramos-Santiago, Curtis Blades, James D. Gutshall

May 2020

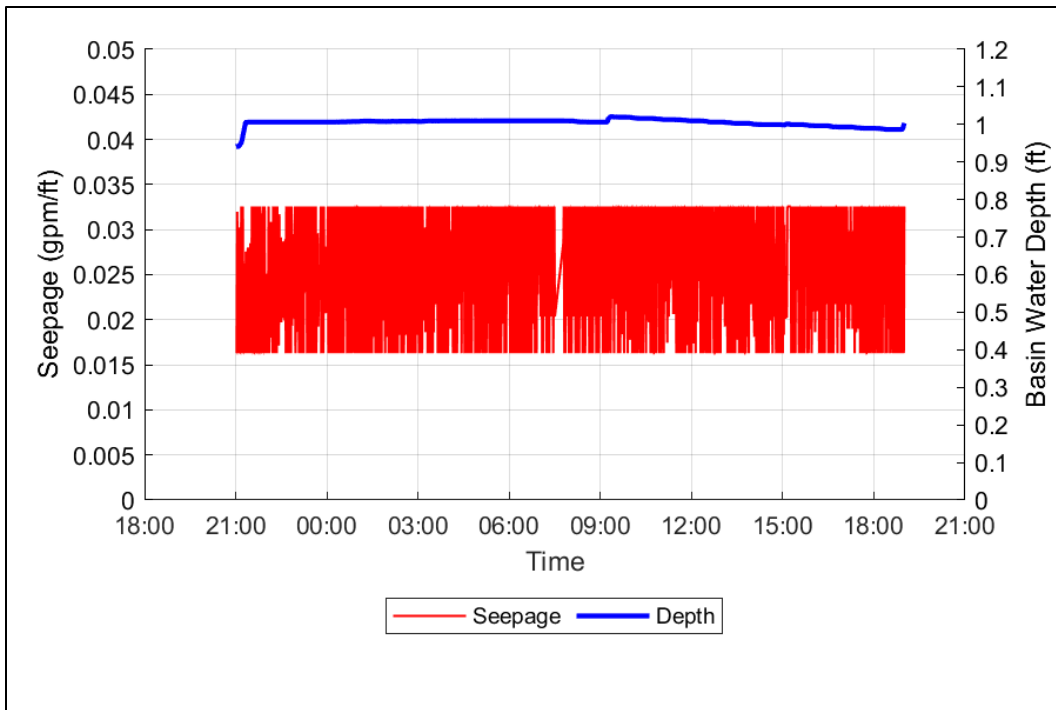
Figure 16. Seepage rates of the one-foot depth hydrostatic test.

The pumps were turned on at 16:30 on 25 February 2020 and a depth of one foot in the basin was reached at 21:00. This prolonged filling time (4.5 hours) was caused by having the basin drain valve open unnoticeably. This valve was designed to drain the test basin at a rate of 8 in. per hour when fully opened and is located outside the facility. The one foot hydrostatic test officially began at 21:00, and the seepage and movement data was collected for the next twenty-two hours. The average seepage of the test was 0.0257 gpm/ft. (Figure 16), which included some minor floor crack leaks. Actual measurements of the floor crack leaks were not taken at this depth as they were visibly minor. Still, it can be reasonably assumed that there was at least a small increase in seepage due to water intrusion from beneath the basin floor.

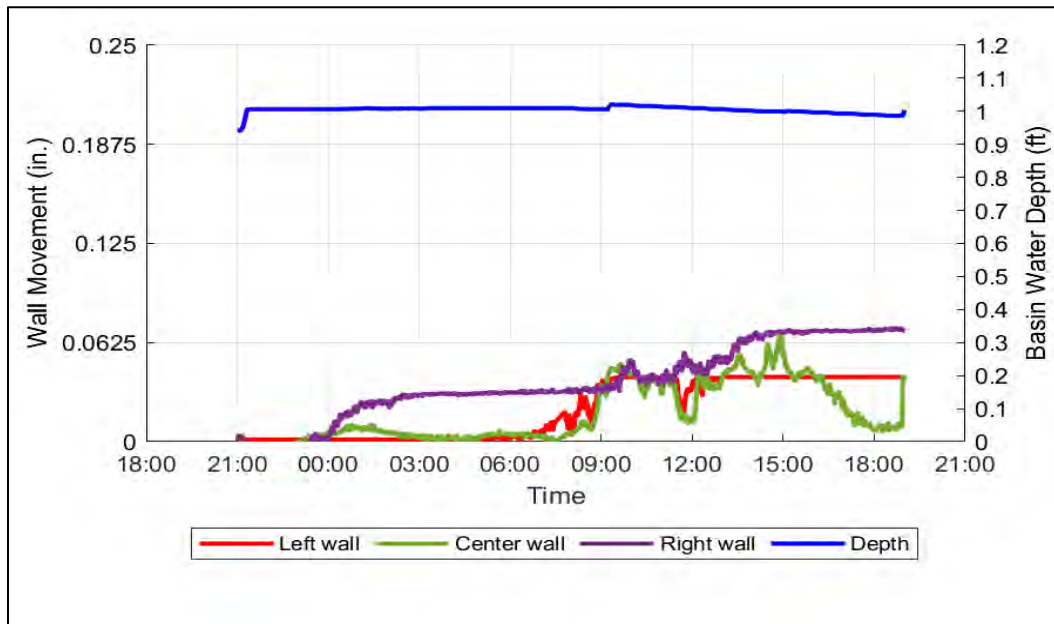
Figure 17. Movement of barrier walls during the one-foot depth hydrostatic test.

The correction factors were then added to the laser movement measurements. The barrier movement was computed by subtracting the corrected laser distance measurements to the barrier pre-flooding location. The results for the one-foot depth hydrostatic test are illustrated in Figure 17. By the end of the test, there was no significant measurable movement from the pre-flood location.

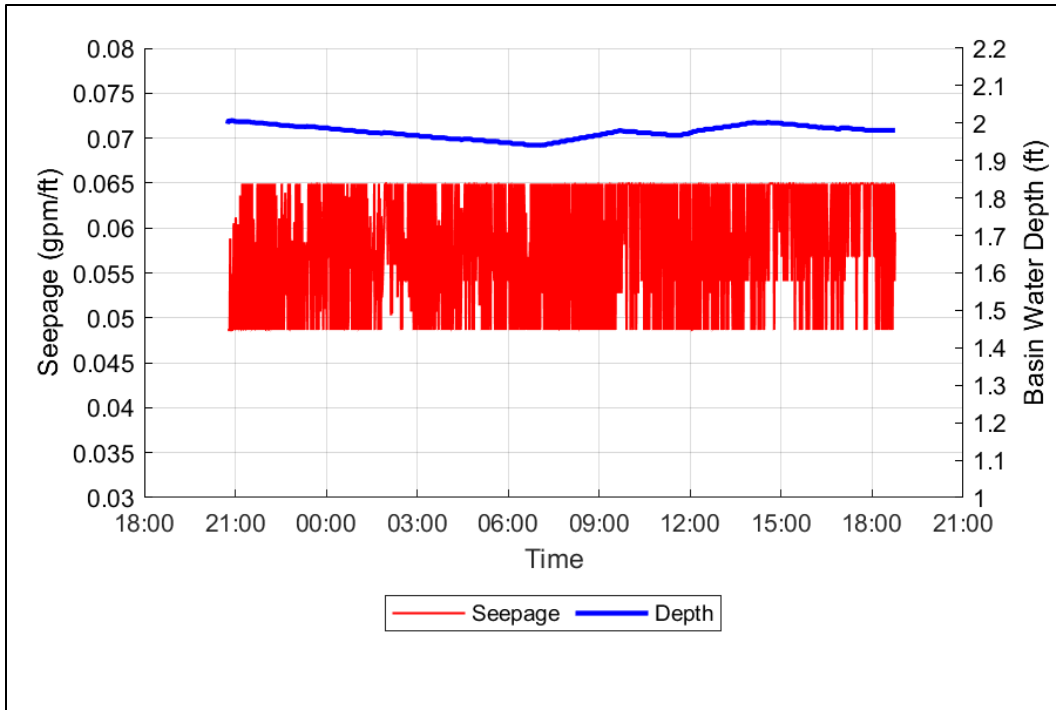
Figure 19. Seepage rates during the two-foot depth hydrostatic test.

The pumps were turned on again at 19:00 on 26 February 2020, right after ending the first hydrostatic test, and a depth of 2 ft. in the basin was reached at 20:45. Seepage increased as the water level in the basin was raised from one foot to two feet. The average seepage of the test was 0.058 gpm/ft., after removal of the floor crack seepage. The time series for the two-foot hydrostatic test is shown in Figure 19. A small drop in basin water depth occurred overnight even though the automatic water valve was open. This valve has the size of a garden hose (~5/8 in.). When the CHL staff arrived next day at 07:00, the pumping system from the main reservoir was turned on to quickly refill the basin.

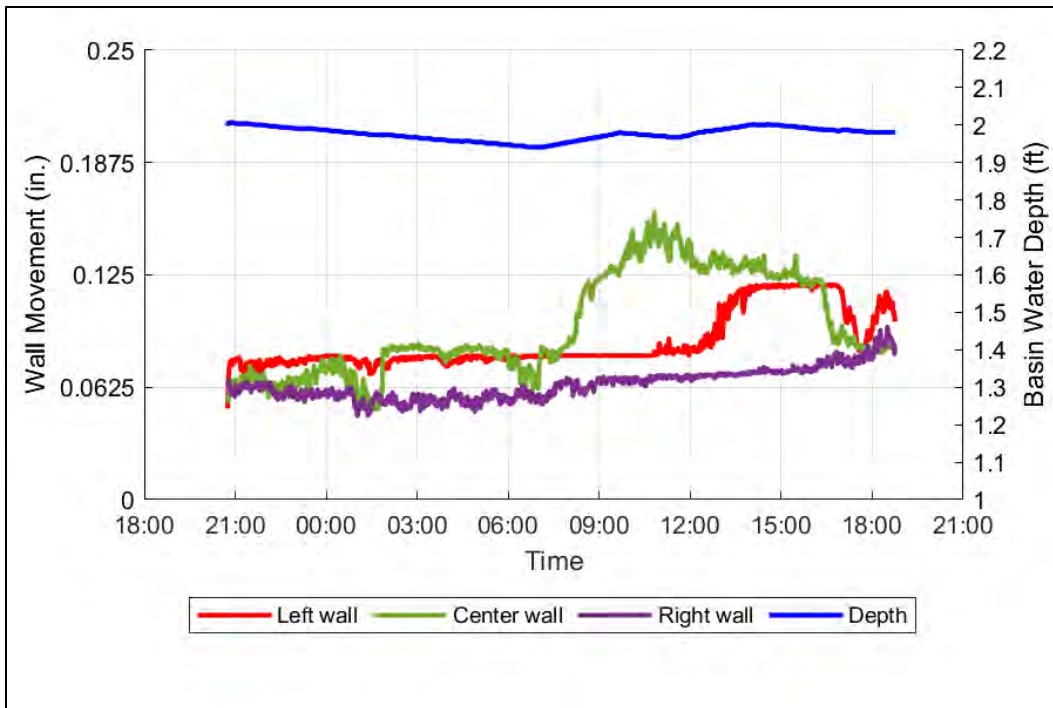
Figure 20. Movement of barrier during final two hours of two-foot hydrostatic test.

The flood barrier movement time series for the two-foot hydrostatic test is illustrated in Figure 20. As with the previous test, no significant displacement of the three walls was observed ($< 1/8$ in.).

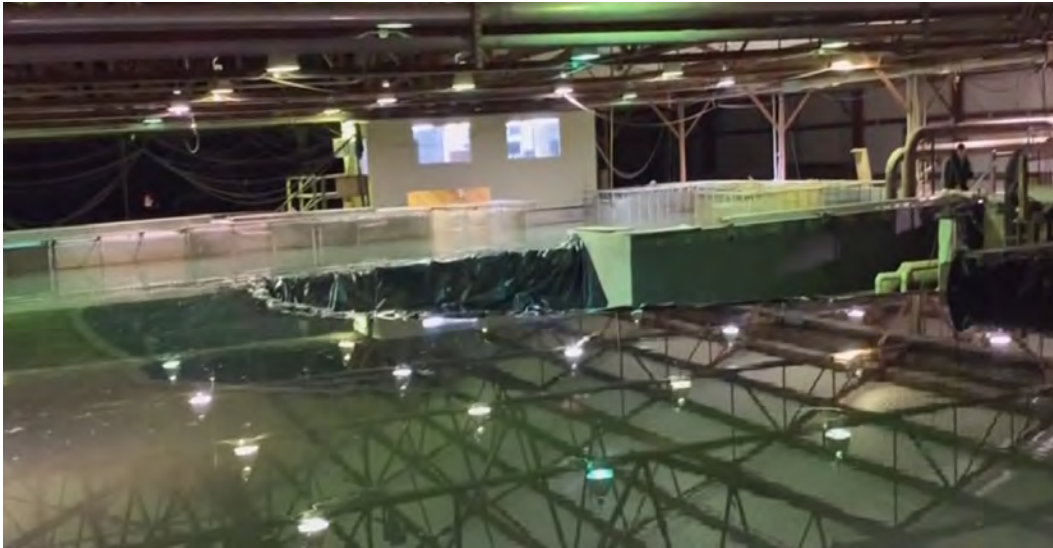
Figure 21. Barrier holding back water at 100 percent of structure height.

A third static water test was conducted at a basin depth of 100% of the structure design height. Even though the 4-Foot Muscle Wall is designed for a working height of 3.96 ft. (47.5 in.), it was decided to use a maximum structure height of 3.94 ft. (47.25 in.). The pumps were turned on again at 19:05 on 27 February 2020, after ending the second hydrostatic test. At 22:14, the pumps were turned off since a water depth of 3.95 ft. (47- 7/16 in.) was reached. At this depth water overtopped the flood barrier at multiple spots of the center and left walls. According to the FM 2510 Standards, Chapter 4, a ± 0.5 in. water depth margin is permitted. Therefore, the basin water depth was reduced to the lower allowed margin of 3.89 ft. (46.75 in.) in order to avoid overtopping. This was attained at 22:33 when the 22-hour test officially started. A picture of the flood barrier under this condition is shown in Figure 21.

Seepage increased as the water level in the basin was raised from 2 ft. to 3.89 ft., as expected. The average seepage of the test was 0.135 gpm/ft., after subtracting the 0.006 gpm/ft. floor crack seepage (see Table 2). A segment of the seepage time series for this test is shown in Figure 22. After completion of this test, the drain valve was opened at 20:45 to lower the basin water depth. At 22:30 the drain valve was closed, the water depth was 3.46 ft., and the basin was left to drain overnight through floor crack seepage as shown in Figure 23. The average seepage rate dropped during this time (22:30 28 Feb to 08:00 29 Feb) to 0.117 gpm/ft., after removing the effects of floor crack outflow and outliers introduced by the seepage pit pumps.

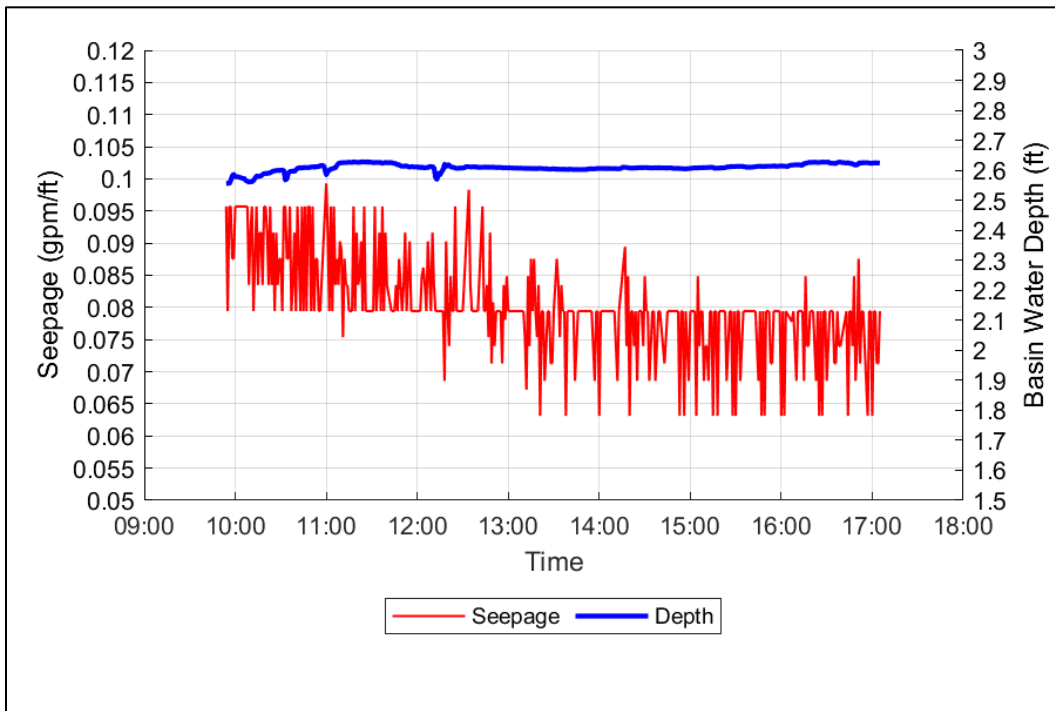
Figure 26. Seepage rates during test with small waves at low water depth.

The seepage rates time series for this test is presented in Figure 26. The trend appears to have an inflexion point near the hour 13:00. This seems to be a continuation of the decreasing trend observed in Figure 23. Since the water depth was reduced by 8 in. in about an hour (between 08:00 and 09:00), it is possible that the floor crack outflow needed more time to stabilize and reflect the rate corresponding to the new water level. The mean seepage rate for the first three hours (09:54 to 13:00) was 0.087 gpm/ft., and 0.078 gpm/ft. for the remaining part. The total mean seepage rate was 0.082 gpm/ft. (all values adjusted for floor seepage of 0.002 gpm/ft.).

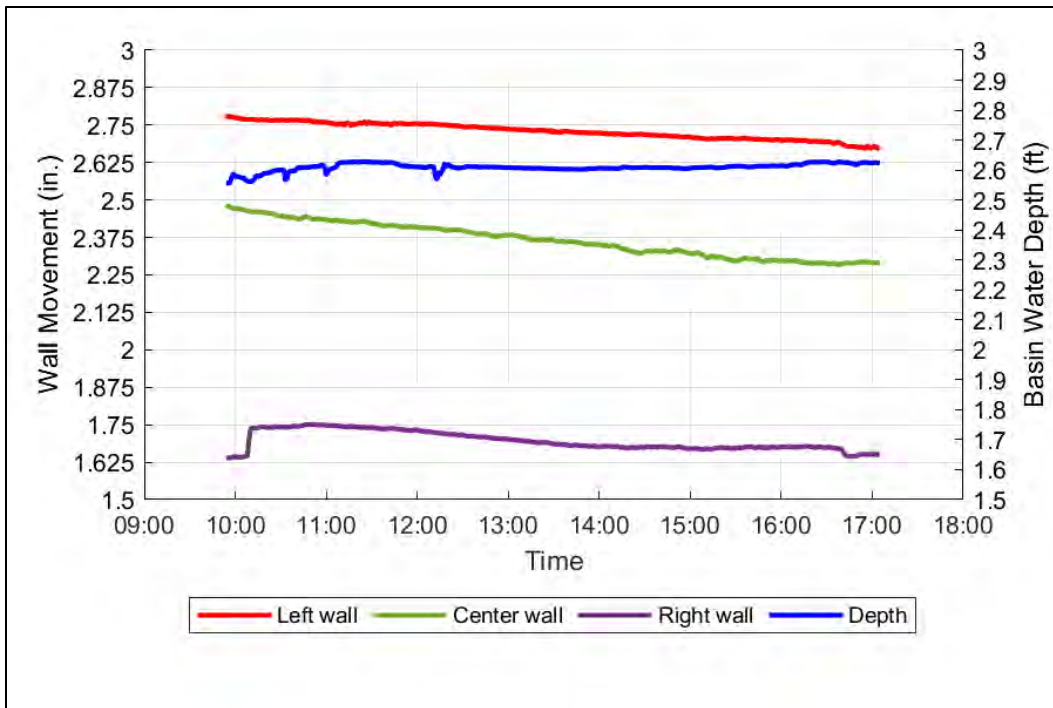
Figure 27. Movement of barrier during test with small waves at low water depth.

There was no overtopping. The movement of the structure was minimal, as shown in Figure 27.

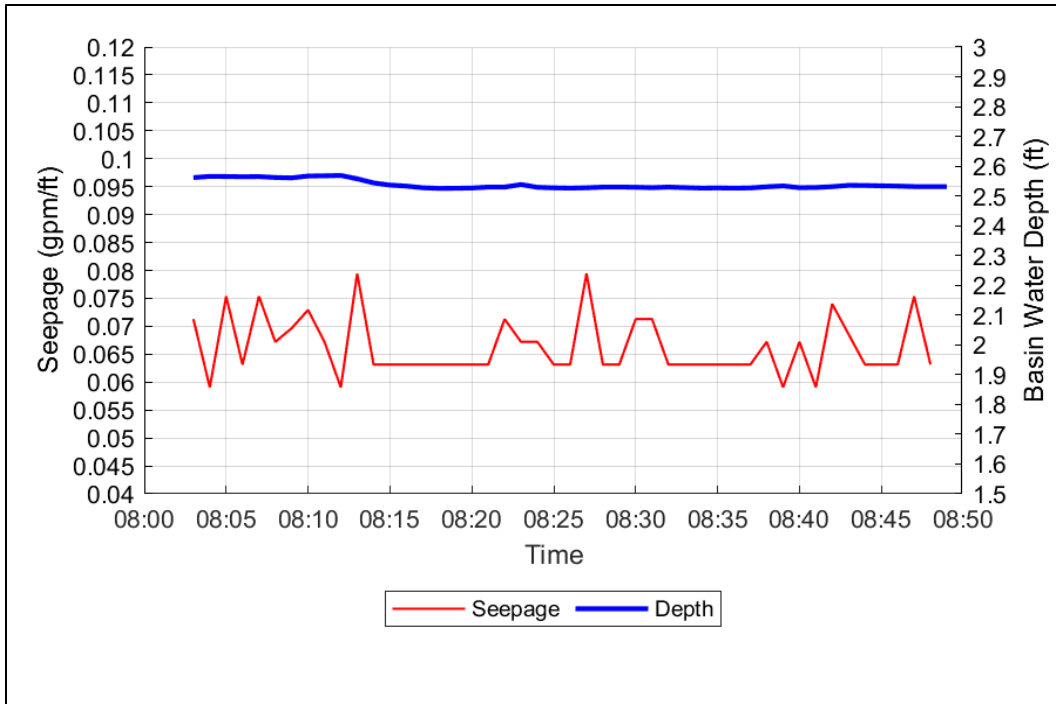
Figure 28. Seepage rates during test with medium waves at low water depth.

The seepage rates time series for this test is presented in Figure 28. The mean seepage rate was 0.066 gpm/ft., after adjusting for floor seepage of 0.002 gpm/ft. No overtopping was observed during this test. No significant movement of the structure was found from the laser data (see Figure 29).

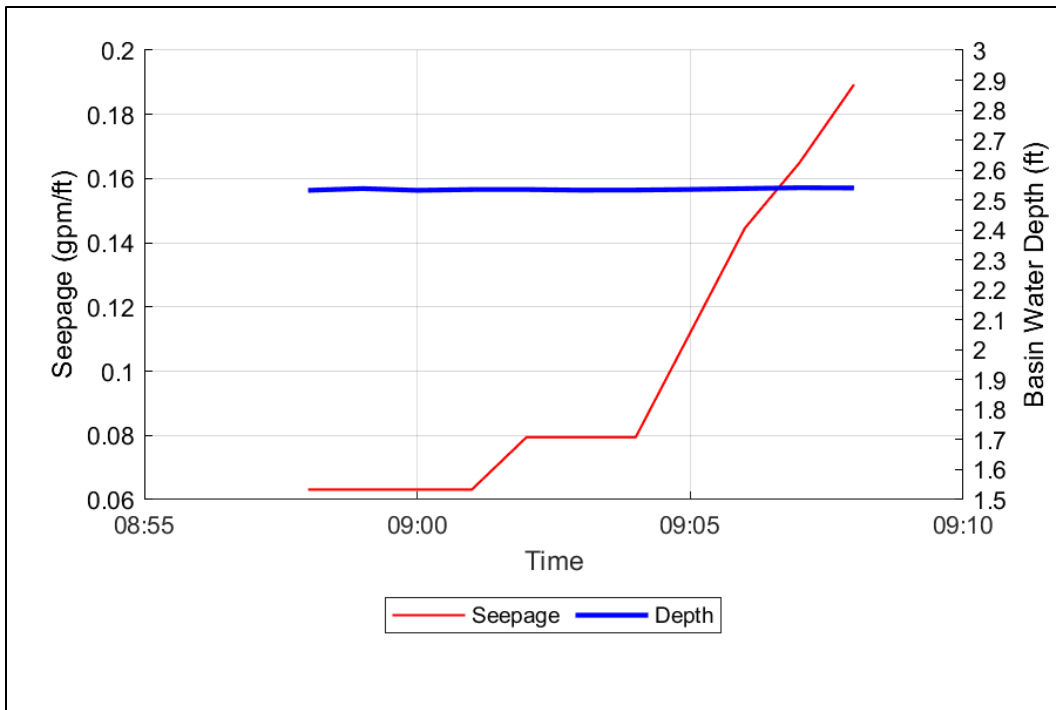
Figure 31. Seepage rates during test with high waves at low water depth.

The large waves were generated for a single 10-min run starting at 08:58. Waves overtopped the left wall near its center and near the wingwall; no overtopping of the right and center walls was observed (Figure 30). Average seepage rate (including overtopping) were 0.100 gpm/ft., adjusted for floor seepage (Figure 31). There was no noticeable movement of the flood barrier walls (Figure 32).

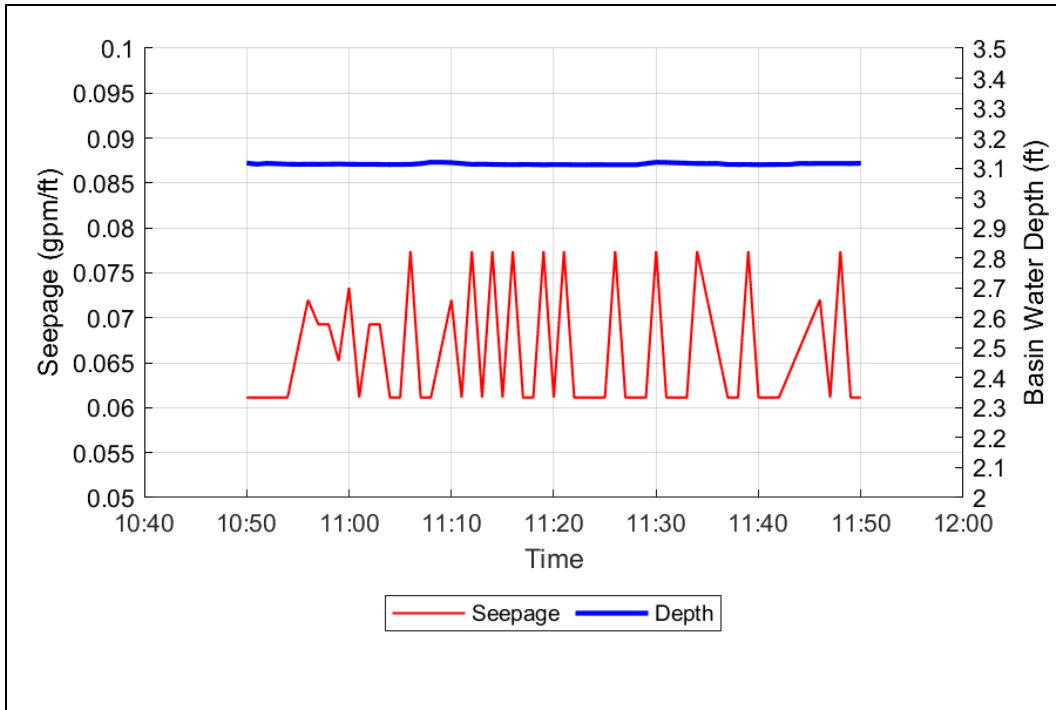
Figure 33. Seepage rates during test with small waves at high water.

The pumps were turned on at 09:15 to raise the basin water depth. The small waves test started at 10:50. Average seepage rate was 0.066 gpm/ft. (adjusted for floor seepage; see Table 2) for the time series shown in Figure 33. According to the laser measurements, the flood barrier walls moved about 0.25 in. while the basin was being filled. However, there were no significant effects found in the data not observed during the test execution. The wall movement is summarized in Table 4, and the time series per wall are illustrated in Figure 34 for the basin filling time period and the test duration.

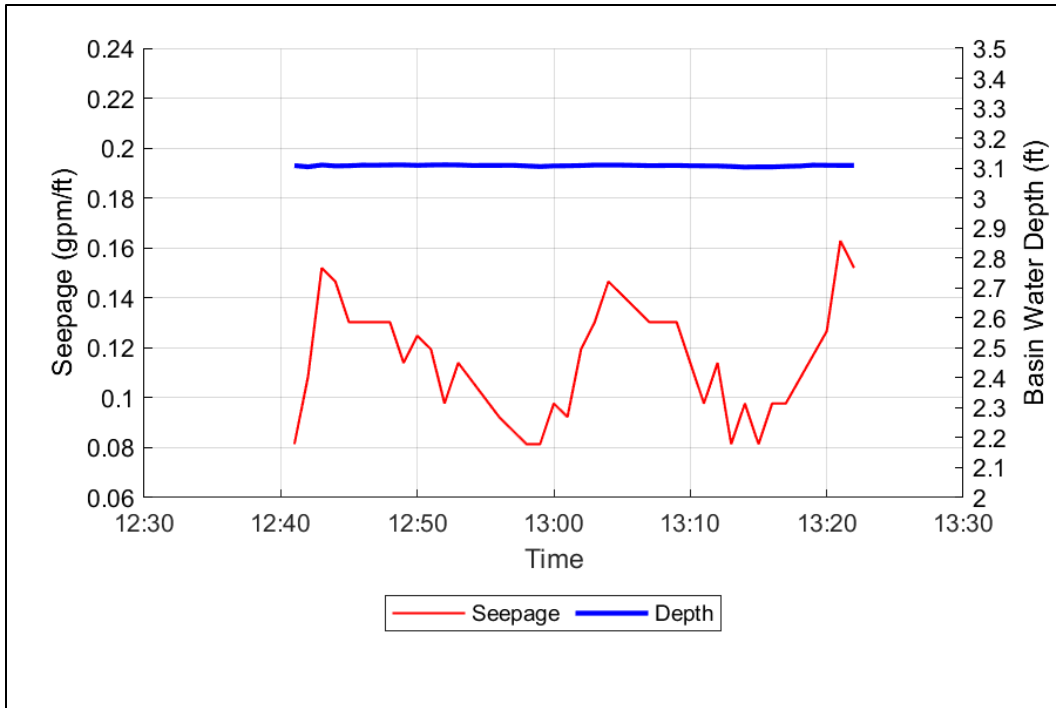
Figure 36. Seepage rates during test with medium waves at high water.

Overtopping was observed near the center of the left wall. The peak measured overtopping rates (one-minute average) was 0.16 gpm/ft. and the average overtopping rates for the 10-min runs was 0.12 gpm/ft.

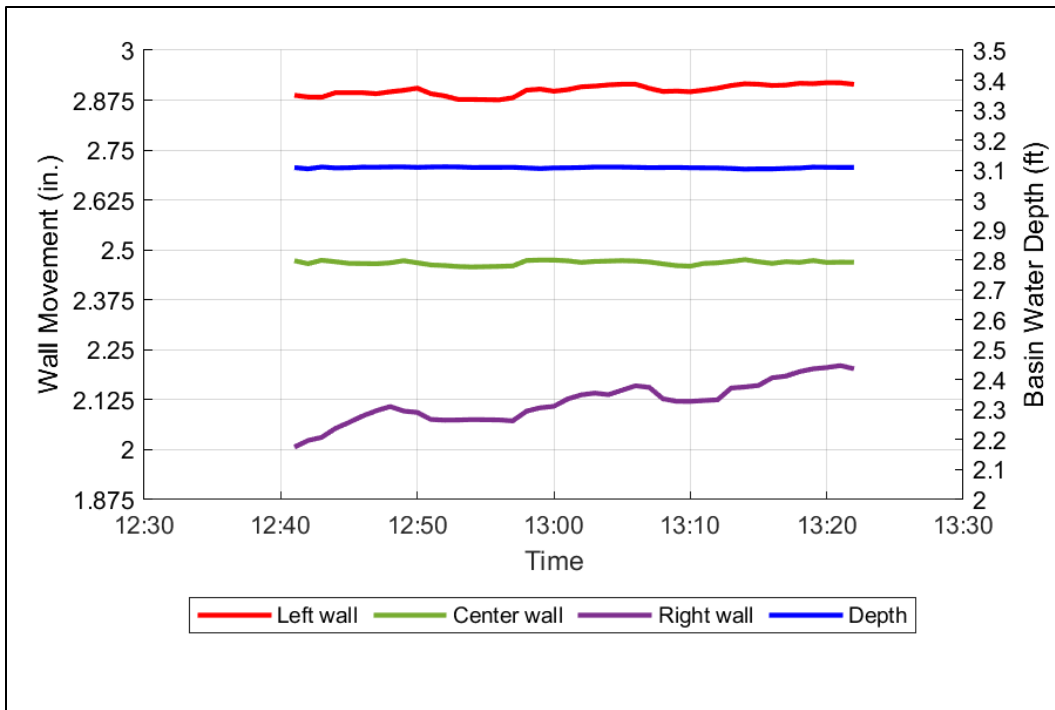
Figure 37. Movement of barrier during test with medium waves at high water.

Although no movement of the barrier was observed during the tests, the data show a slight movement inward for the right wall (about 0.25 in.). The medium waves had little effect on the left or center walls (Figure 37).

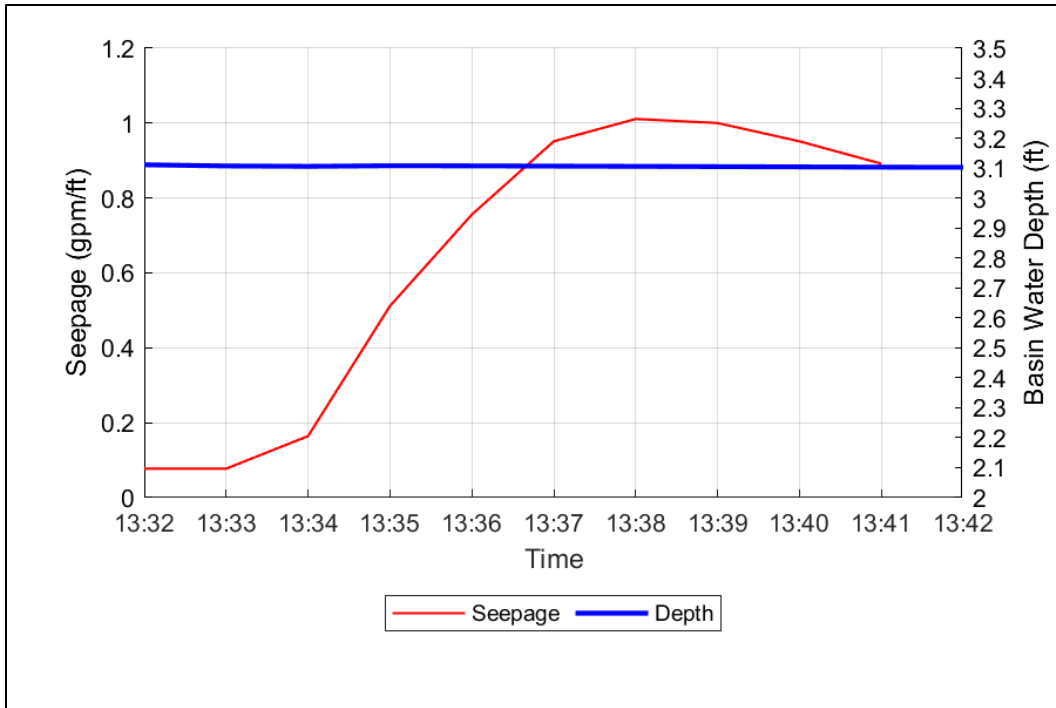
Figure 38. Seepage rates during test with large waves at high water.

The 10-minute large waves test started at 13:32. Overtopping occurred at the center of the left side wall and at its connection with the wingwall. The waves were also splashing the right side wall near the wingwall. The overtopping reached a peak of over 1.011 gpm/ft. and averaged 0.639 gpm/ft. (Figure 38). No significant wall movement was observed (Figure 39).

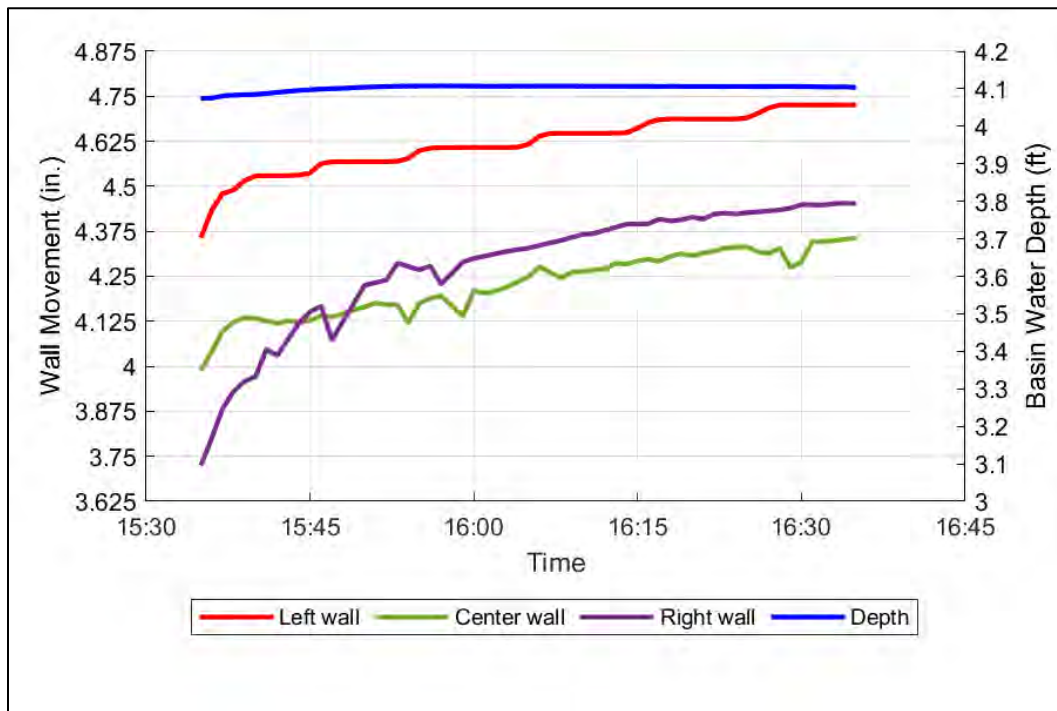
Figure 41. Movement of barrier during overtopping test.

An average of one inch overtopping was estimated to be reached at 13:35 at a basin depth of 4.1 ft. The test was successfully conducted. The seepage pit pumps were turned off in order to use the diesel pumps. No problem arose with the diesel pump system that recirculates the water to the basin. The laser system continued to collect wall movement data (Figure 41). The maximum inward movement of the each wall recorded by the lasers was as follows: 4.73 in. at left wall, 4.36 in. at center wall, and 4.45 in. at right wall. This quantities are a total respect to the pre-flood wall position measured the first day of this study.

Throughout the test, the 4-Foot Muscle Wall retained structural integrity and suffered no noticeable damage.

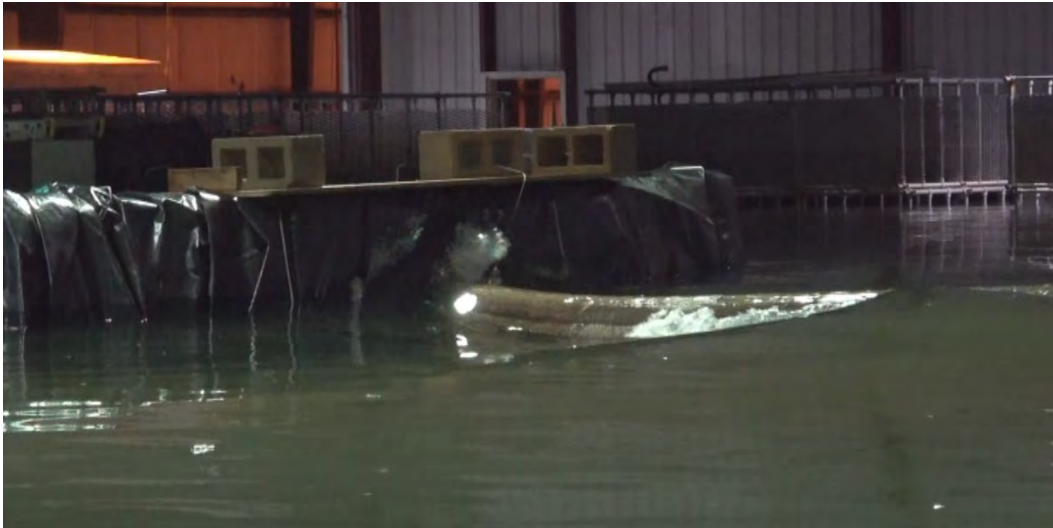
Figure 44. Snapshot of the large log impacting the center wall.

is obtained when the log is pulled to about a foot from the barrier’s center wall. Afterwards, the test was conducted successfully and neither log caused any noticeable damage to the liner cover or to the structure. The debris impact tests were conducted at a water depth of 66.7% of structure design depth. During this test, it went unnoticed that the laser stopped measuring the basin water depth. The foam buoy got stuck when the basin was completely drained and the laser signal was lost. Meanwhile, a wooden ruler was used to check the water depth.

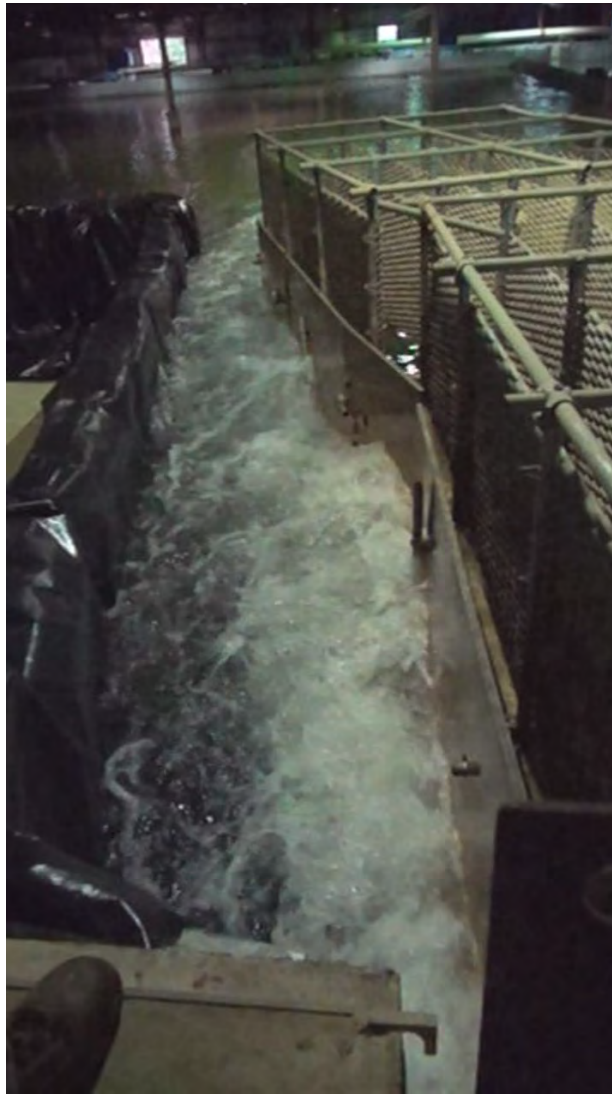
Figure 48. Snapshot of the riverine current test (taken from on top of the right wingwall).

The average seepage rate recorded by the laser system was 0.186 gpm/ft., after removing the estimated 0.002 gpm/ft. floor crack outflow (refer to Table 2). This is the same rate recorded during the debris impact test earlier that day. The seepage pit pumps were still off. No significant

changes in leakage through the wall was observed inside the dry-zone, compared to what was seen when the impact test was performed. Still, the mean value is still below the 0.25 gpm/ft. maxima required by the FM 2510 Standard, Chapter 4.

The movement values measured with the lasers at the end of test are summarized in Table 6, along the values reported for the debris impact test. The right wall appears to have moved inward about a quarter of inch during this test. No damage to the barrier was observed during the current test.

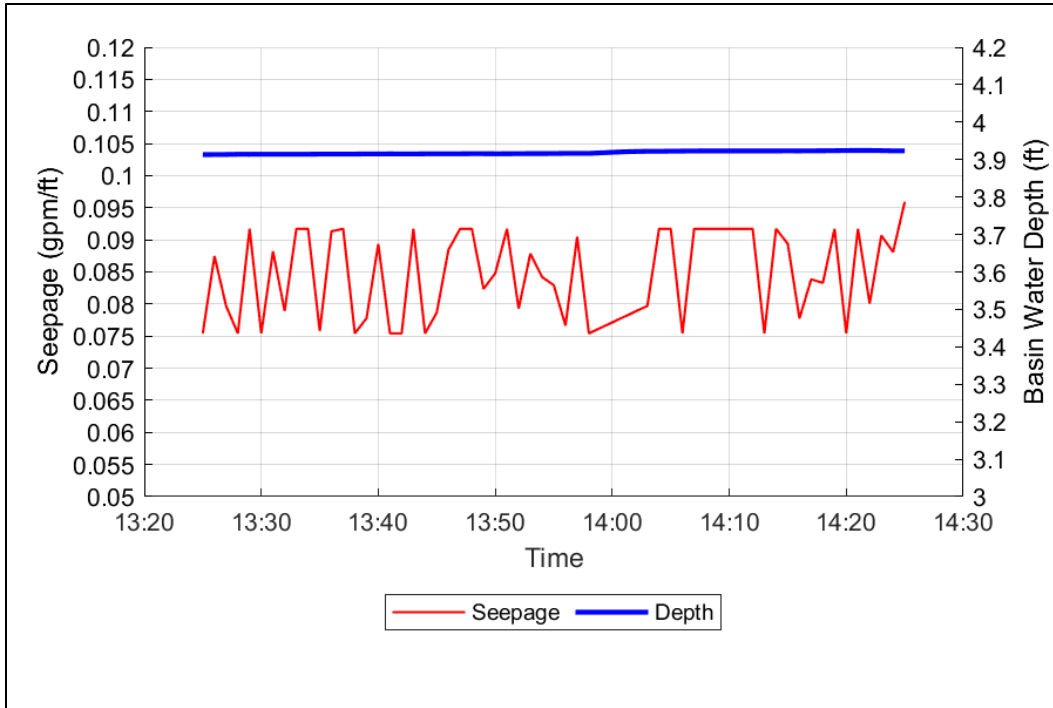
Figure 49. Seepage rates during post hydrostatic test.

The pumps were turned on again at 11:30 on 04 March 2020 and a water depth of 3.94 ft. was reached at 13:25. The test concluded at 14:25. Average seepage rate was 0.085 gpm/ft. (adjusted for floor crack outflow; see Table 2) for the time series shown in (Figure 49). The wall movement is summarized in Table 8, and the time series per wall are illustrated in Figure 50 for the test duration. As expected, the barrier walls moved significantly compared to the position recorded by the end of the riverine

current test, but did not surpassed the 6 in. maximum permanent deflection required by the Standards.
